Research Article

Characterization and Mapping of Soil Salinity Status at Small-Scale Irrigation Farm: The Case of Fantale Irrigation Project Sites

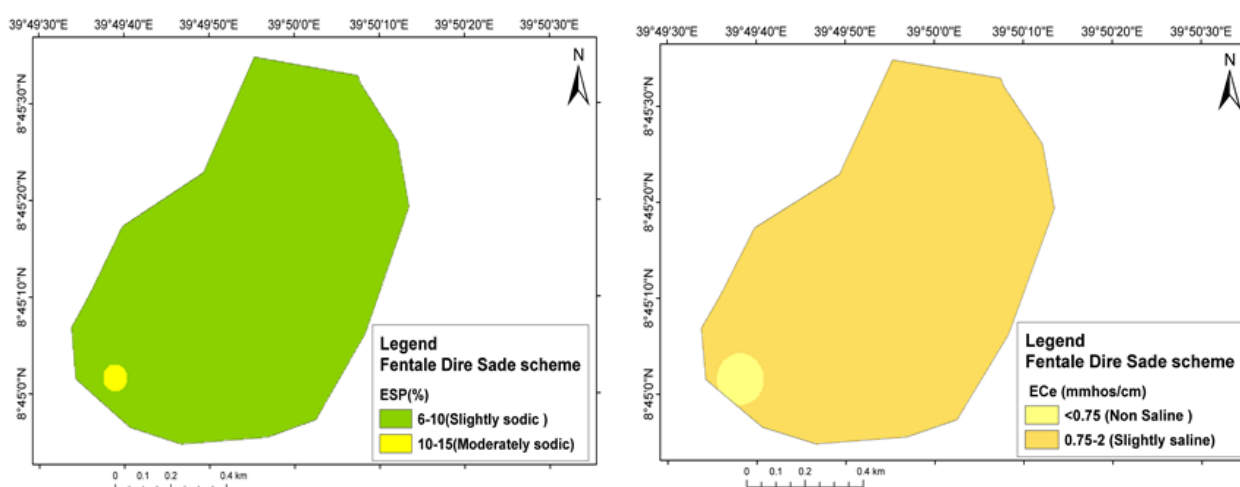
Figure 2. Map indicating the level of ESP and EC at Dire Sadi Irrigation scheme.

Majority of scheme has ESP of 6-10% and EC 0.75-2mmhoms/cm (Figure 2). Therefore, based on [8], system of soil salinity classification, soil salinity of Dire Sadi irrigation scheme was categorized as slightly sodic and slightly saline.

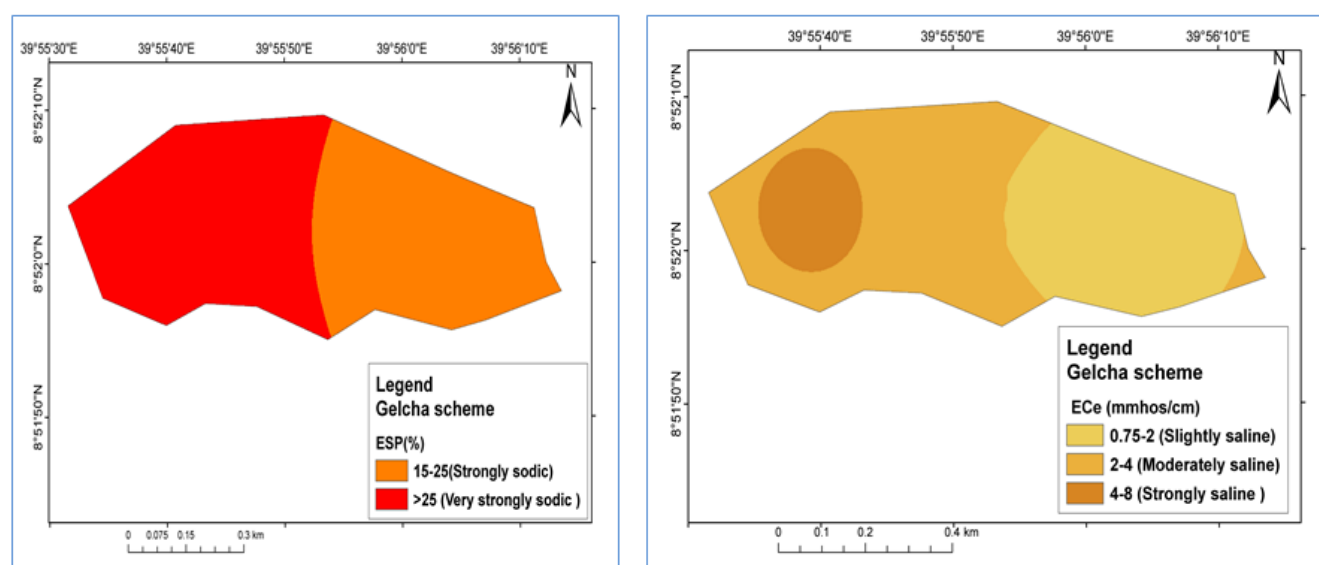
**Figure 3.** Map indicating the level of ESP and EC at Galcha Irrigation scheme.

Majority of scheme has ESP of 15-25% and EC 2-4mmhoms/cm (figure 3). Therefore, based on [8], system of soil salinity classification, soil salinity of Galcha irrigation scheme was categorized as strongly sodic (figure 3).

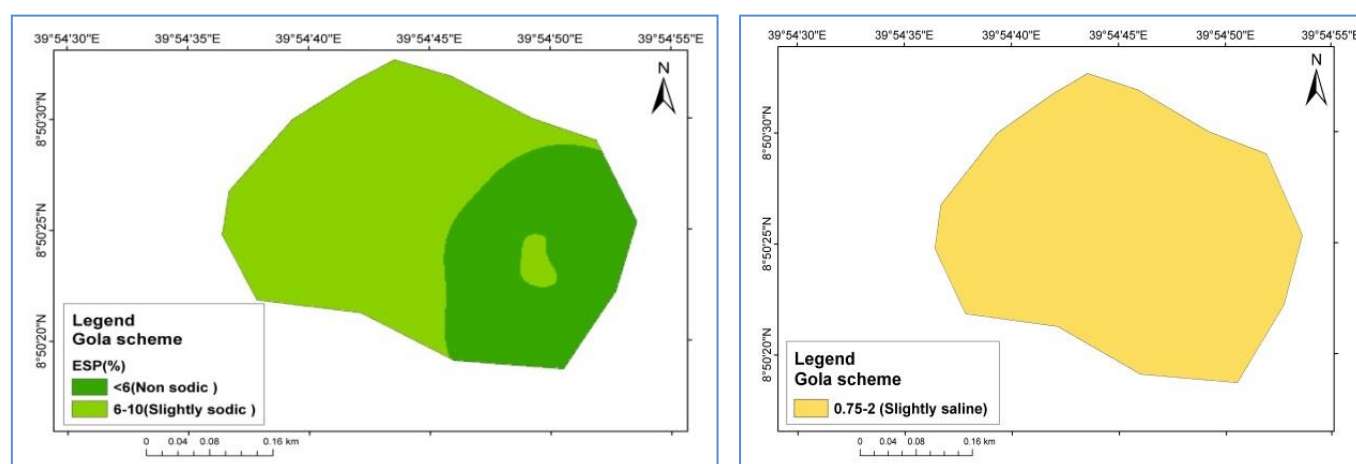
Figure 4. Map indicating the level of ESP and EC at Gola Irrigation scheme.

Majority of scheme has ESP of 6-10% and EC 0.75-2 mmhoms/cm (figure 4). Therefore, based on [8], system of soil salinity classification, soil salinity of Gola irrigation scheme was categorized as slightly sodic (figure 4).

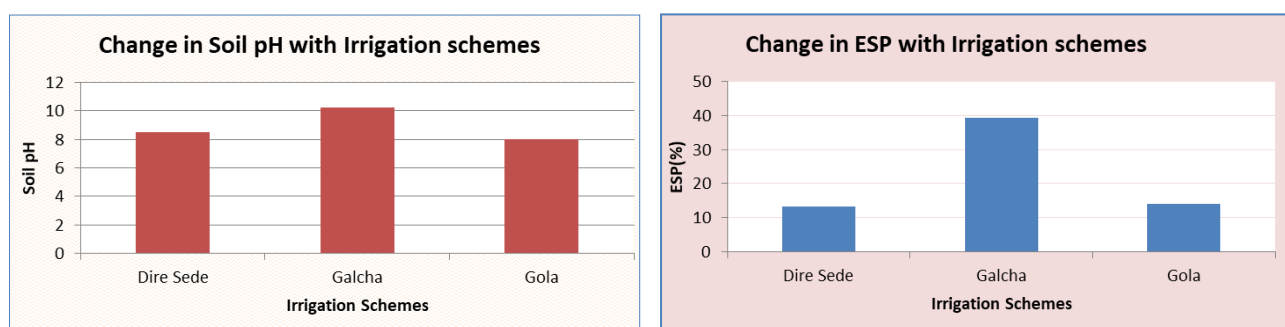
Figure 5. Level of soil pH and ESP at selected Irrigation schemes.

soil depth was increasing (figure 6). This due the decrease in sodium accumulation while increased concentration of calcium with increased depth. Soil pH, EC, Ca²⁺ and ESP were higher at Galcha irrigation scheme as compared with other schemes (figures 5 & 6).

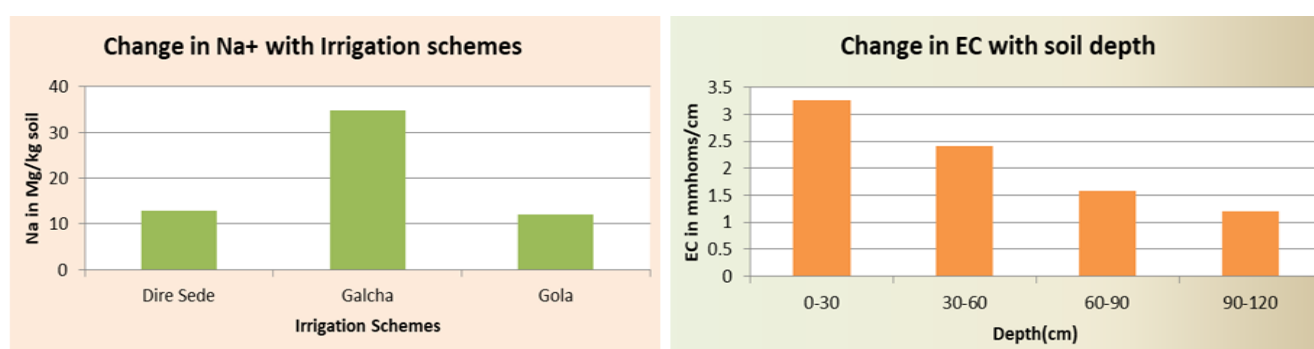
Figure 6. Level of soil EC, Na+ at selected Irrigation scheme.

Soil pH and accumulation of calcium in the soil showed an increasing trend as the sampling depth was increasing to 120cm. On the contrary, ESP and EC were decreasing as the
